MARINE INVESTIGATION REPORT

M99C0027

GROUNDING

**PRODUCT CARRIER “SUNNY BLOSSOM”
ENTERING THE CORNWALL CHANNEL,
ST. LAWRENCE SEAWAY
16 JULY 1999**

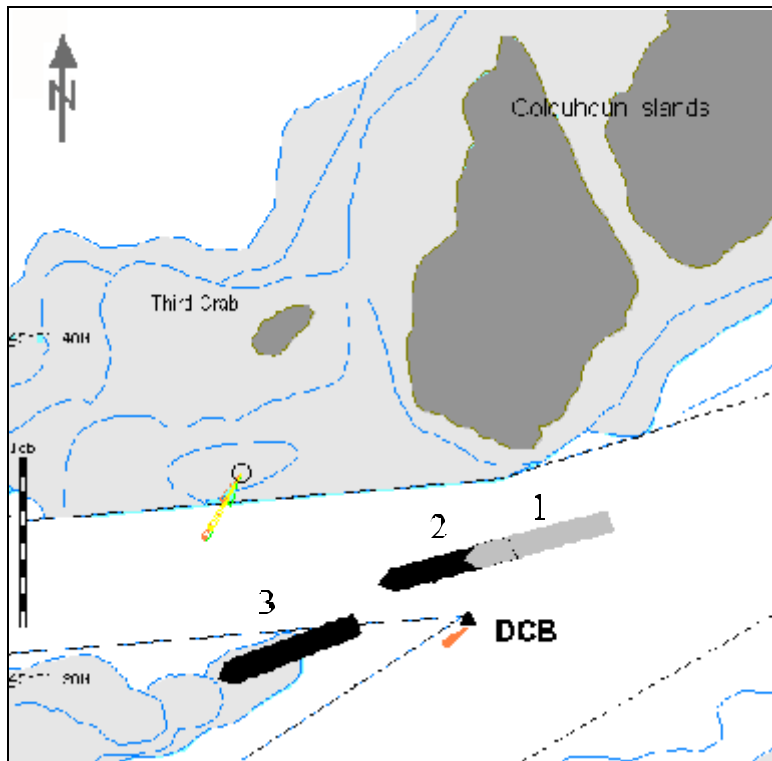
Sketch 1

Notwithstanding the differences of opinion on why the helm was put to port, all those on the bridge agreed that the vessel went aground as a result of the helm being put over to port instead of to starboard, and that this occurred at a critical time during the course alteration. Between the time that the helm was put to port, about 1154, and the movement of the vessel to port, some time elapsed.⁵ It is estimated that the “SUNNY BLOSSOM” would have taken about 25 seconds to start its swing to port from the time that the initial helm order was given. At 8 knots, the distance covered would have been about 103 m. From the position at 1154, the

103 m covered on a course of 255°(G) would have placed the vessel in an unrecoverable position, given that the rudder was at this time 20 degrees to port with the engine full ahead and a port swing started, and notwithstanding a current setting at 060°(T) at this position.⁶

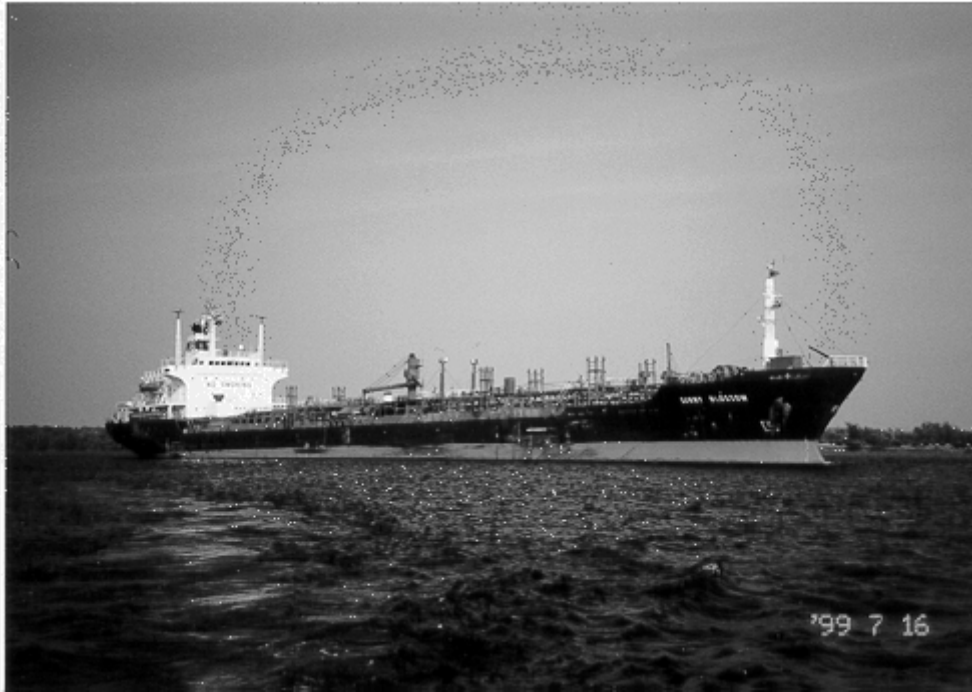
"SUNNY BLOSSOM" AGROUND OUTSIDE THE CORNWALL CHANNEL

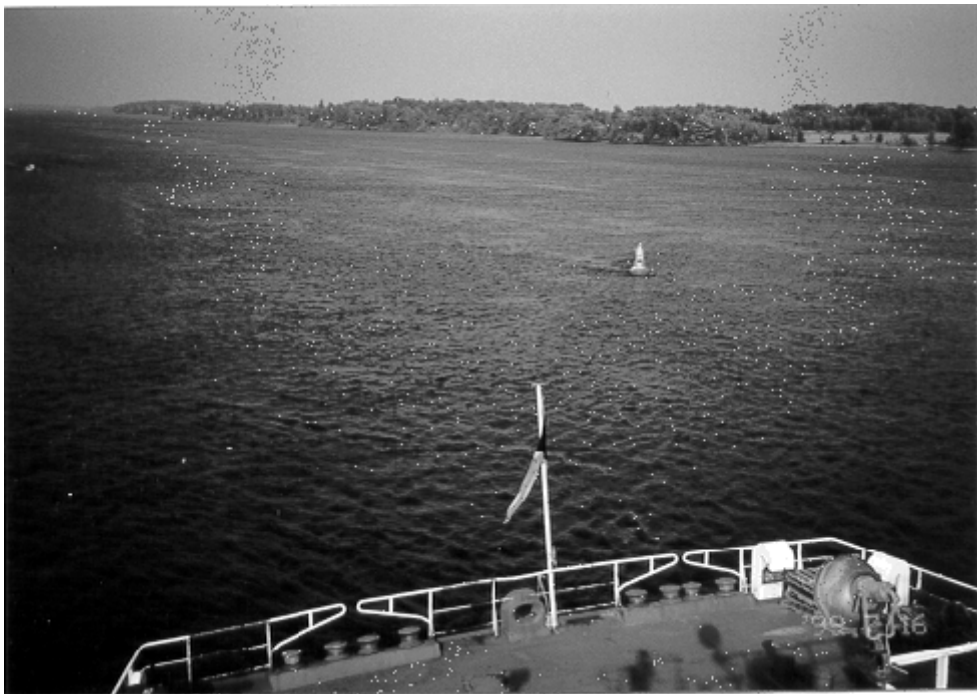
BUOY DCB OFF THE PORT QUARTER
